**Flood Control Project Maintenance
Levee Inspections**

Fall 2015 Levee Maintenance Deficiency Summary Report

Sacramento River Basin

Reclamation District No. 0537 Lovdal

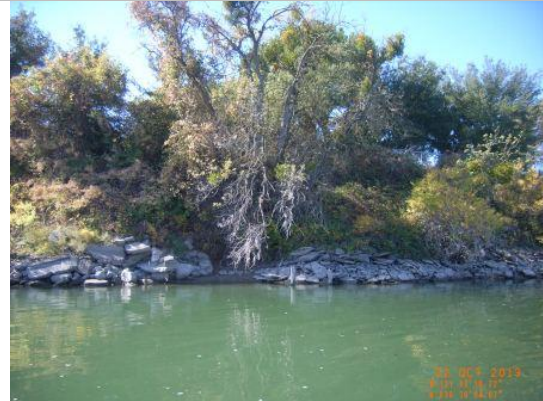
USACE 2013 Photo #1

LM Start	4.27	Rating **	M	Issue No.	1
LM End	4.32	Issue Type +	Ma	Location *	WS
Category	Supplemental			GPS Latitude/Longitude	
				Start	End
Item	2015 USACE Erosion Survey, DRAFT			38.601388 °	38.600907 °
				-121.553250 °	-121.552815 °
DWR ID					
Action/Comments					
Inspector Comments: 1997 - This may have been a cobble rehabilitation site to the 1957 cobble that was place all the way to the I-80 Bridge. 2000 - Local damage induced by human use. 2003 - Site is still very close to the levee and into the levee toe. 2011 - One new tree has fallen. 2015: 62.9 and 63.0 have been combined into one site. [2015 Site ID: SAC_62-9_R]
